Update "With-Site-Visit" Reserve Study

Crestview Chateaux HOA Chandler, AZ

Report #: 34441-0
For Period Beginning: January 1, 2019
Expires: December 31, 2019

Date Prepared: May 14, 2018

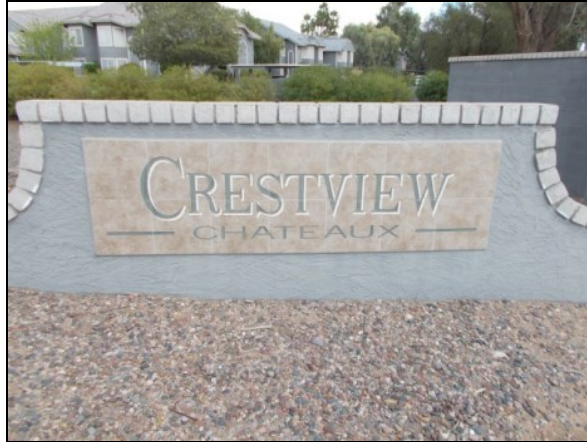
History: Replaced during 2005. Previously original from 1985.

Evaluation: Monument consists of a 7'x2' tile sign mounted to the perimeter stucco wall. There are no cracks or chips visible. Still appears to be in good shape.

Useful Life:
20 yearsRemaining Life:
6 years

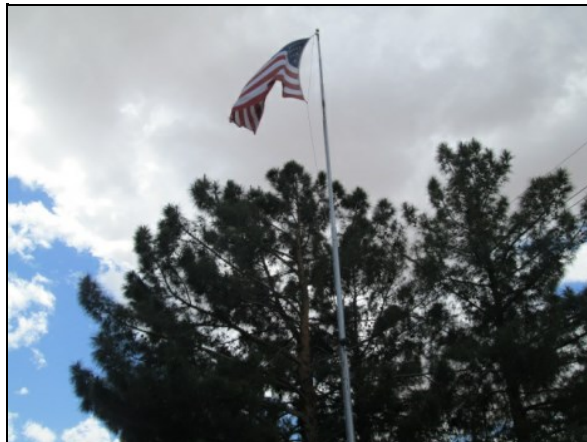
Comp #: 120 Flagpole - Replace**Quantity: (1) Flagpole**

Evaluation: This is a 40'-50' telescoping flagpole. It has some rust around the base. The flagpole is mounted in grass which is susceptible to increased weathering.

Useful Life:
40 yearsRemaining Life:
8 years

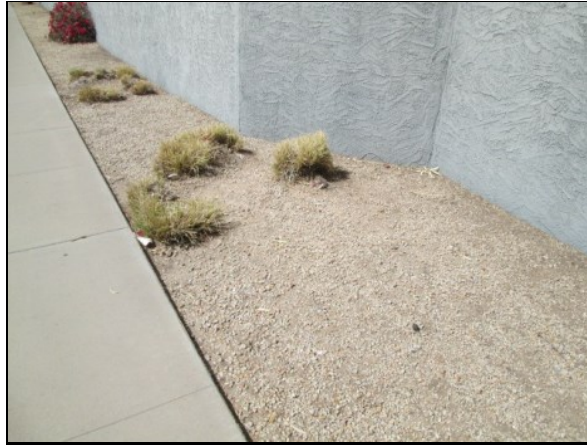
Evaluation: Perimeter areas around the community look old and depleted. Recommend periodically top dressing the granite to maintain and restore the appearance.

Useful Life:
10 yearsRemaining Life:
0 years

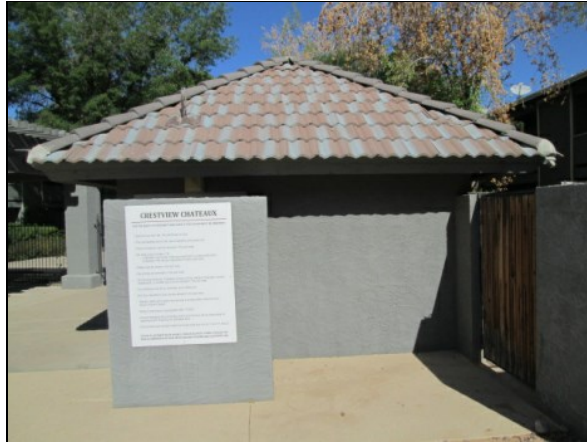
Evaluation: Surfaces appear to be uniform and in fair condition.

Useful Life:
10 yearsRemaining Life:
5 years

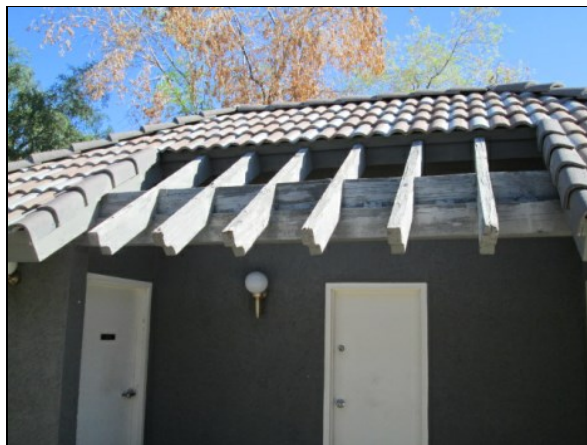
Evaluation: Paint on the wood surfaces is in poor condition. Wood is exposed and the paint is peeling.

Useful Life:
5 yearsRemaining Life:
0 years
