Update "With-Site-Visit" Reserve Study

Crestview Chateaux HOA Chandler, AZ

Report #: 34441-0
For Period Beginning: January 1, 2019
Expires: December 31, 2019

Date Prepared: May 14, 2018

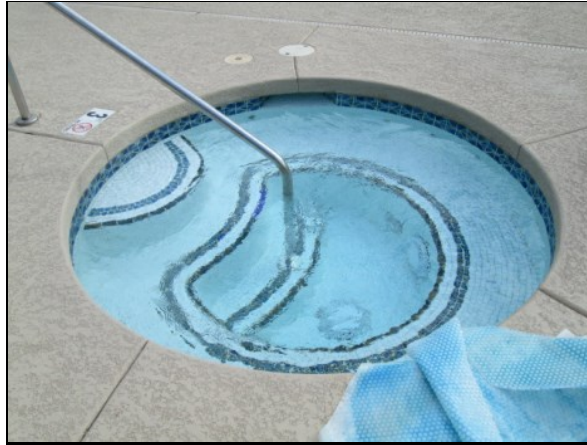
Evaluation: The surface has a tile surface. It is an older surface but still looks decent for its age. Some patching and repair was done in 2017.

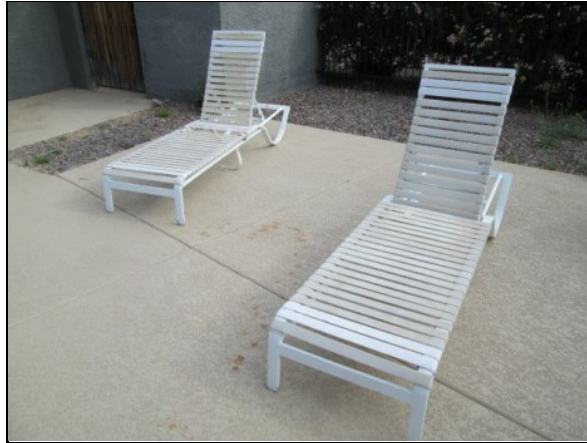
Comp #: 1214 Pool Furniture - Replace (A)**Quantity: (18) Pieces**

History: Replacement is expected before the end of 2018.

Evaluation: Pieces include (12) chairs with straps and (6) lounges with straps. Straps are old and stained; some of them are broken too. Frames have chipped paint and rust as well.

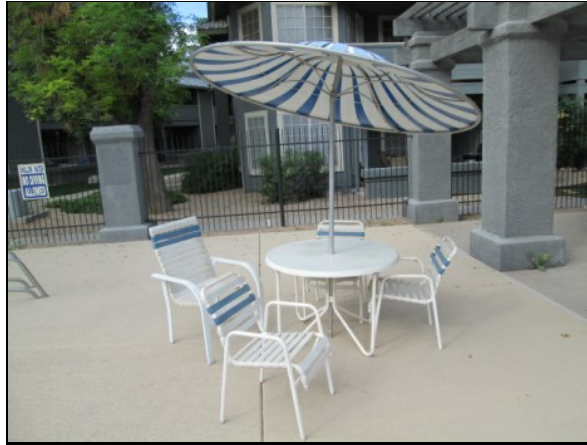
Comp #: 1214 Pool Furniture - Replace (B)**Quantity: (11) Pieces**

History: Replacement is expected before the end of 2018.

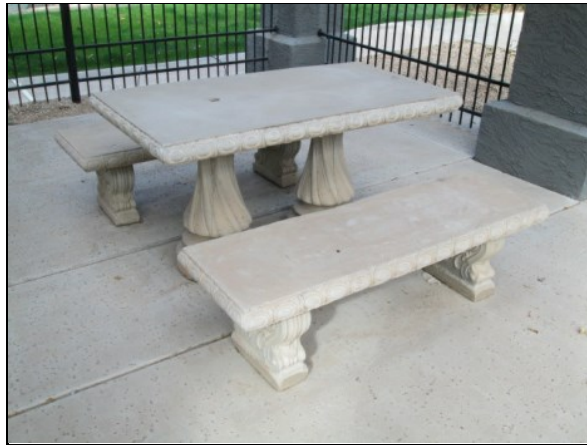
Comp #: 1217 Concrete Furniture - Replace**Quantity: (6) Pieces**

Evaluation: Pieces include: (4) concrete benches and (2) concrete tables. Table sets are older. Some cracks noted. They still look nice and have a decorative style.

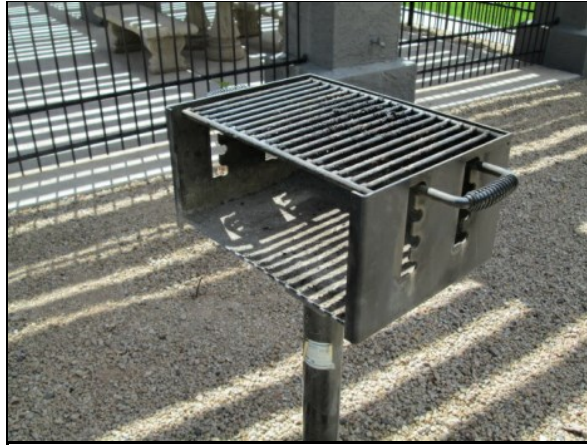
Comp #: 1218 BBQ Grill - Replace

Funded?: No. Cost is below the Reserve expense threshold. Recommend replacing as needed with Operating funds.

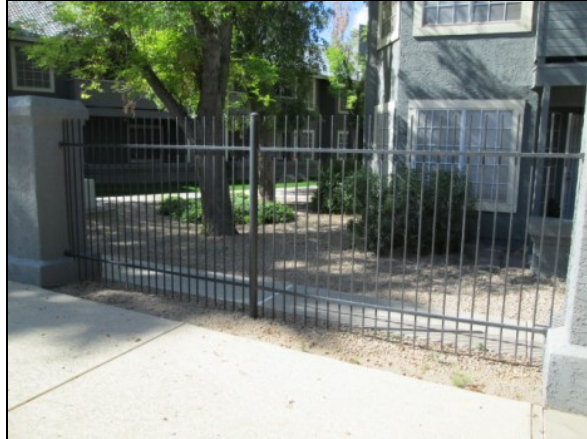
Comp #: 1220 Metal Fence - Replace

Evaluation: Looks older but is still in fair condition. There is rust in some areas. Some of the fencing is loose.

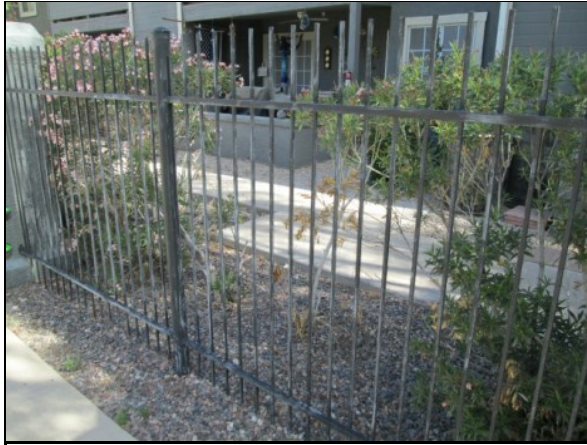
Evaluation: Fence surfaces look older but are still in fair condition overall. Some rust spots noted, but they are not too bad.

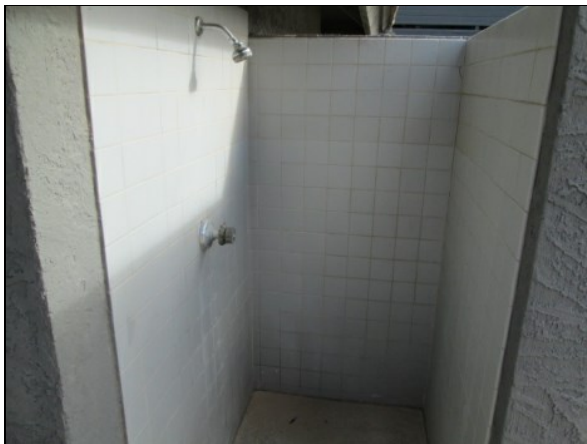
Comp #: 1228 Shower Tile - Replace

Funded?: No. Cost is below the Reserve expense threshold. Recommend replacing as needed with Operating funds.

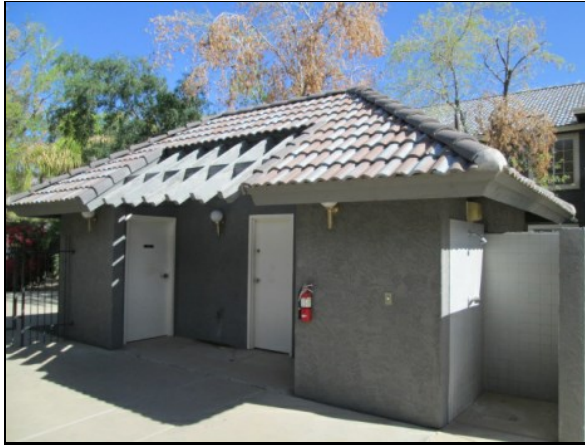
Funded?: No. Restrooms are very basic, so a complete remodel is not anticipated here. Recommend replacing items as needed with Operating funds.

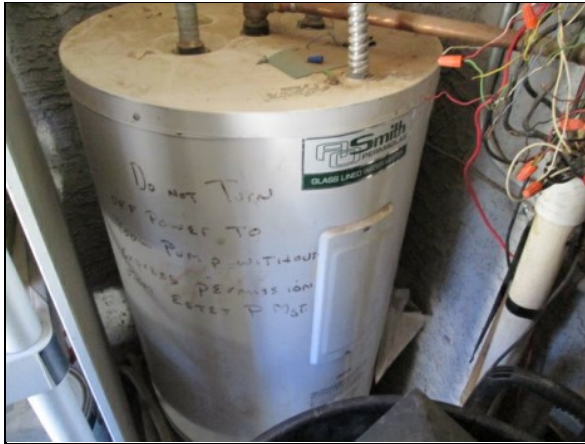
Comp #: 1234 Water Heater - Replace

Funded?: No. Cost is below the Reserve expense threshold. Recommend replacing as needed with Operating funds.

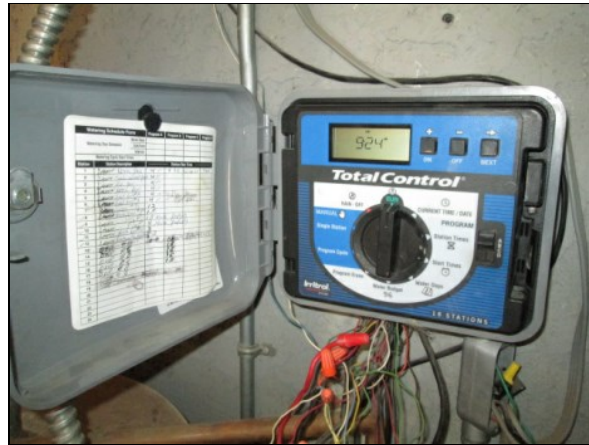
Comp #: 1236 Irrig. Controllers - Replace

Funded?: No. Cost is below the Reserve expense threshold. Recommend replacing as needed with Operating funds.

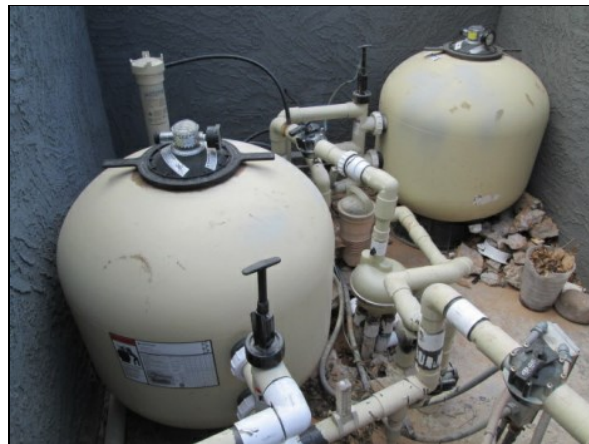
Comp #: 1240 Pool Filters - Replace

History: Replaced during 2016. Previously installed during 1994.

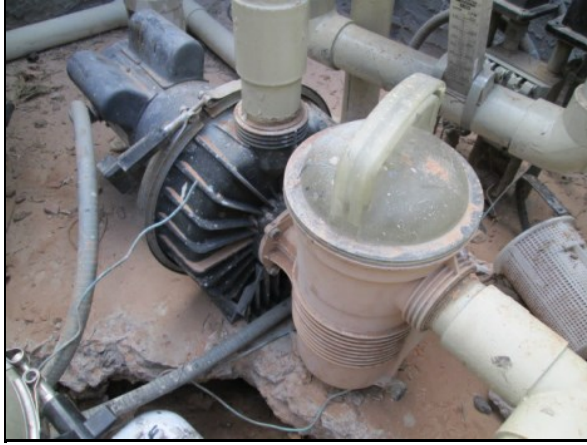
Comp #: 1242 Pool/Spa Pumps - Replace

Funded?: No. Individual costs are below the Reserve expense threshold, so replacement will be treated as an Operating expense.

Evaluation: These pumps all vary in age, so there is no expectancy to replace them at the same time.

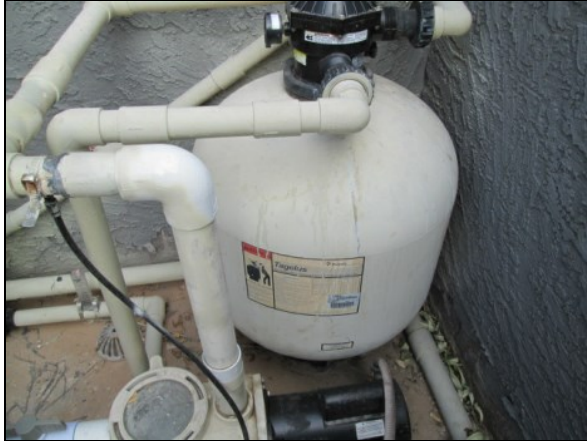
Comp #: 1250 Spa Filter - Replace

Funded?: No. Cost is below the Reserve expense threshold. Recommend replacing as needed with Operating funds.

History: Replaced around 2008.

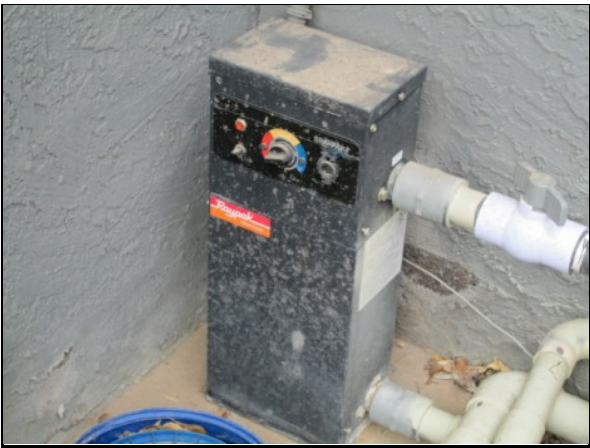
Comp #: 1256 Spa Heater - Replace

Funded?: No. Cost is below the Reserve expense threshold. Recommend replacing as needed with Operating funds.

History: Replaced in 2014.

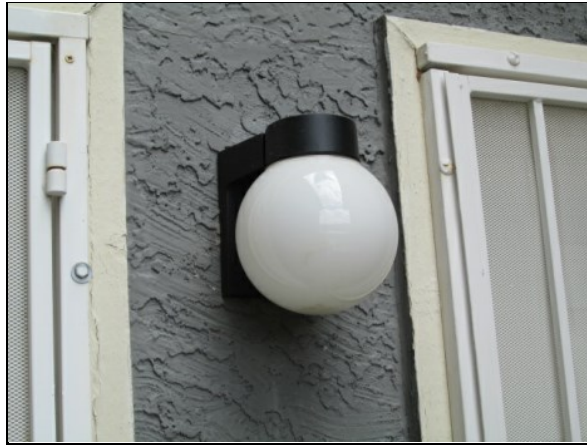
Comp #: 800 Exterior Lights - Replace

Evaluation: These lights are old and look dated. Many owners have replaced their light, so they are no longer match and look uniform. Replacement is not a priority at this time, but it should be planned periodically to update and modernize the lighting while also maintaining uniformity.

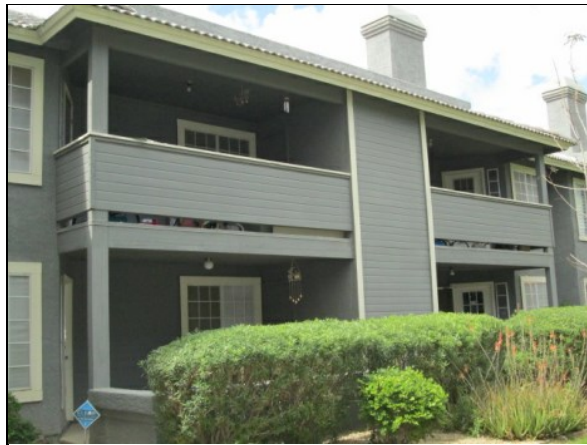
Comp #: 820 Balcony Decks - Repair

Evaluation: Decks are expected to be lightweight concrete, so there are no replacement issues to plan for under normal circumstances.

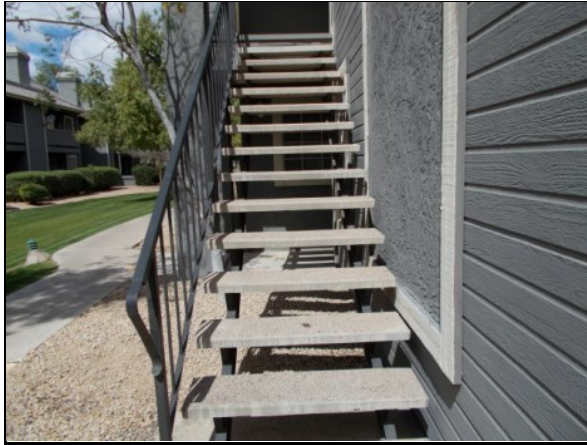
Comp #: 850 Stair Steps - Replace

Funded?: No. HOA plans to replace as needed with Operating funds, so no Reserve funding has been allocated.

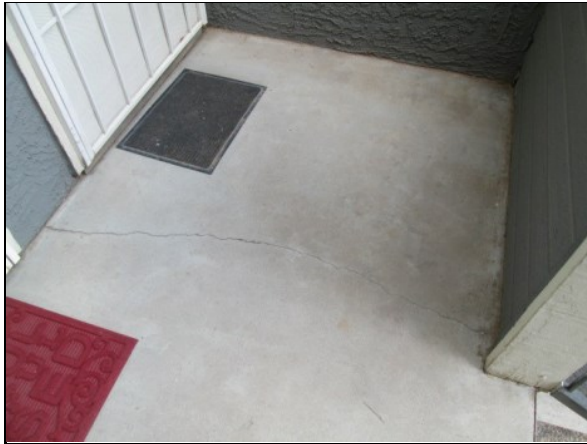
Comp #: 860 Stair Landings - Repair

Funded?: No. Stair landings are concrete with no coatings to maintain. There is no expectancy to replace this concrete under normal circumstances, so no Reserve funding has been allocated. Treat repairs as a maintenance project if needed.
